DIMENSIONAL CHANGES IN SHOT GUN BARRELS CAUSED BY THE FIRING OF HARD METAL PELLETS

by C. DAYSON AND T. MALONEY

SUMMARY

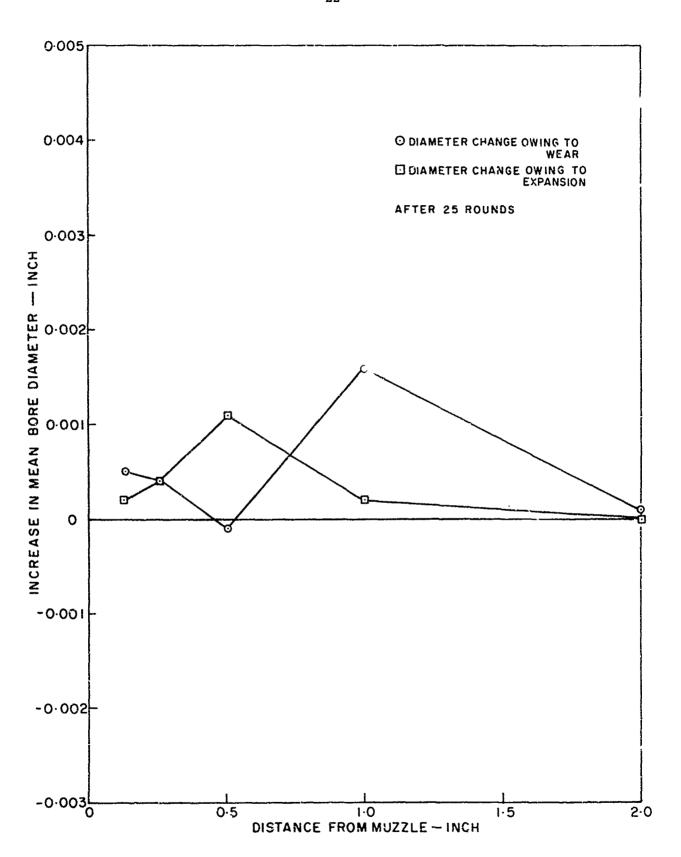
FIG.8: CHANGES IN BORE DIAMETER OWING TO WEAR AND EXPANSION, CARBONYL NICKEL SHOT

because of the latter effect. Also $(d_2-D_1+D_1-d_1)$, where d_1 and d_2 are the bore diameters before and after firing, is a measure of the change of internal diameter caused by wear. Both these parameters are plotted in Figure 8. Since both parameters contain the external diameters D_2 and D_1 , their values could only be established at stations where the external diameter was measured.

It appears from Figure 8 that the changes in the barrel dimensions evident in Figures 5 and 6 were due partly to barrel expansion and partly to the wear occurring in the bore. However, the scatter in these results, which are typical of those obtained with the other hard metal pellets, is plainly of the same order as the changes in diameter due to both these effects. This is shown by making a comparison with the curves of typical error; Fig. 3. Therefore, it was decided that it was necessary to fire a greater number of rounds of the test shot from each barrel. The results of measurements obtained after a further 75 rounds had been fired are given in Figures 9 to 29 for all the types of shot tested. The results for Teflon-coated shot, Figures 27 to 29, refer to measurements made after 25 rounds; the barrel split during the second series of firings as a result of metallurgical defects in the steel (Ref. 4).

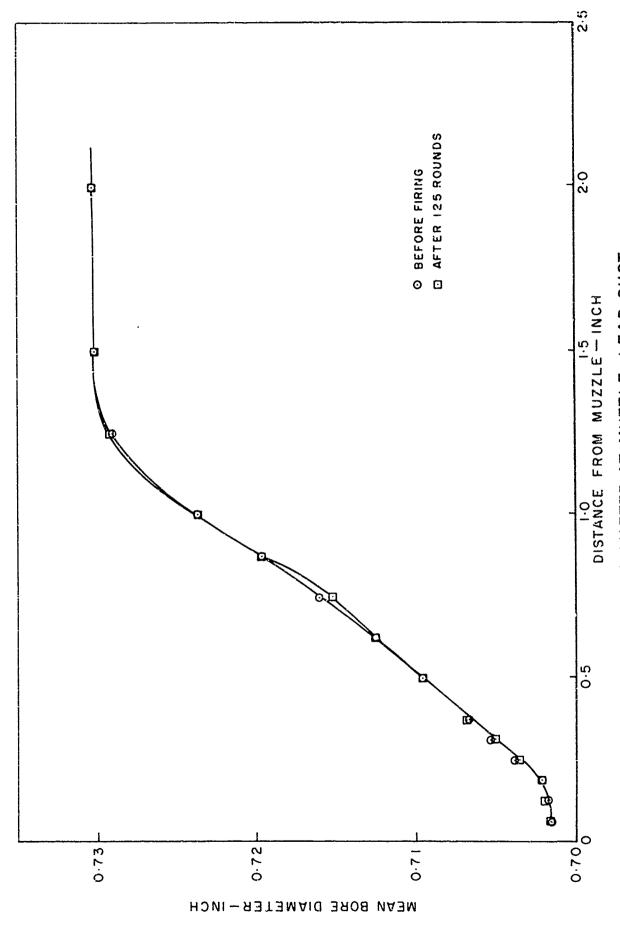
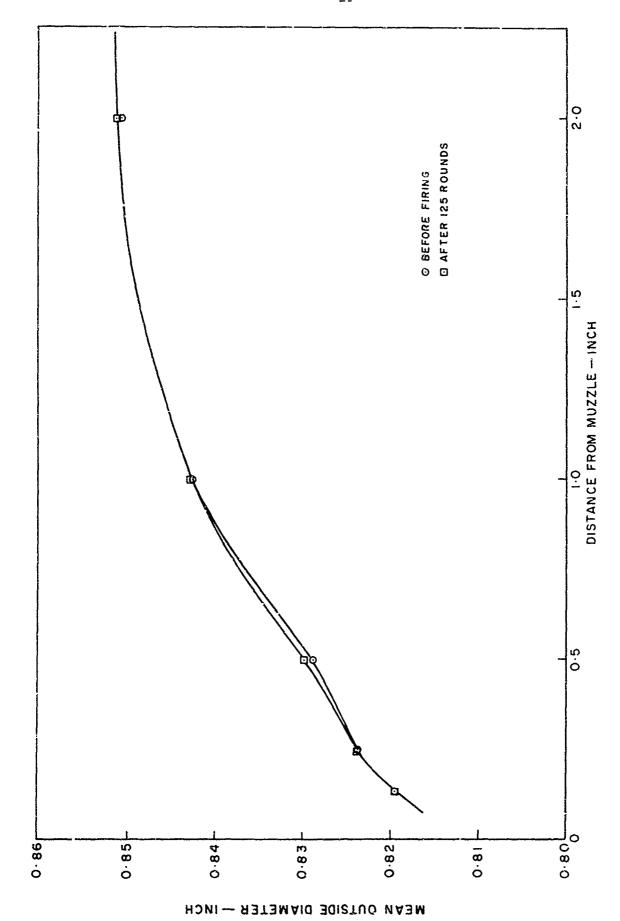
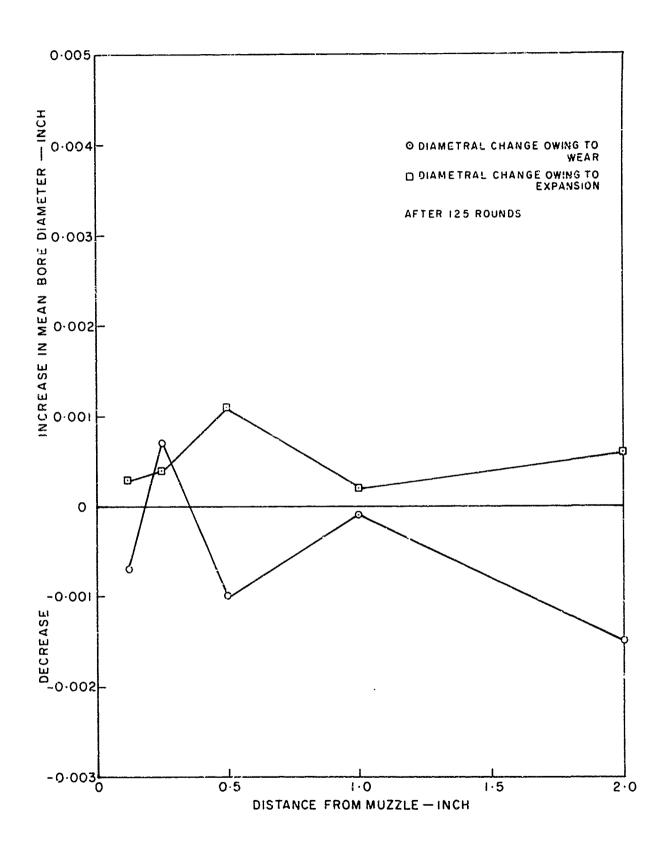
Figures 9 to 11 show the measured changes in the dimensions of a barrel from which 125 rounds of lead shot were fired. Clearly the amount of wear or surface damage was immeasurable; the changes owing to wear and expansion of the barrel (Fig. 11) are of approximately the same magnitude as the measurement errors. This result was expected since it is found that, in practice, many thousands of rounds can be fired without any barrel damage becoming apparent. Roughness measurement results are given in Table 2; the small but significant increase in the roughness in this case was probably due to a thin layer of lead that seemed to have been deposited on the hore.

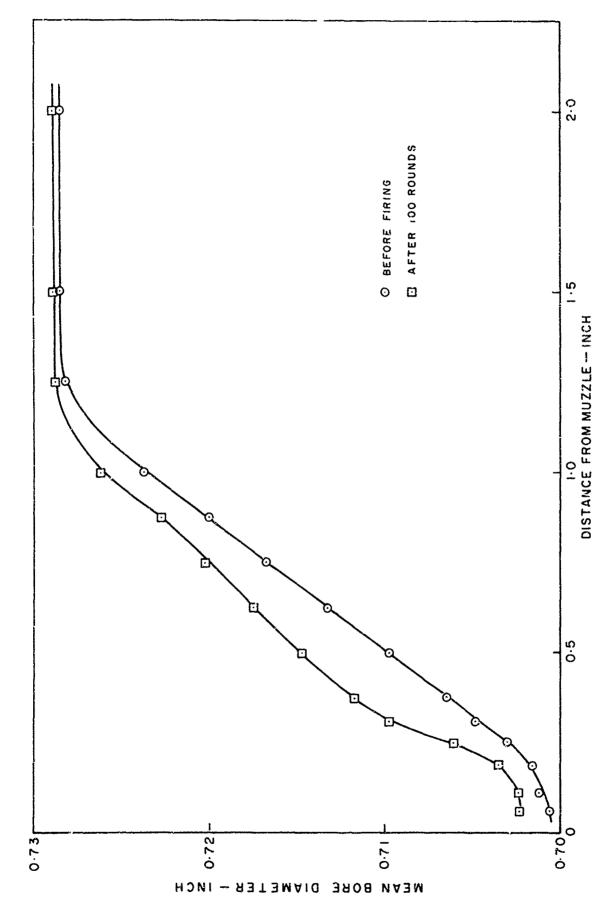
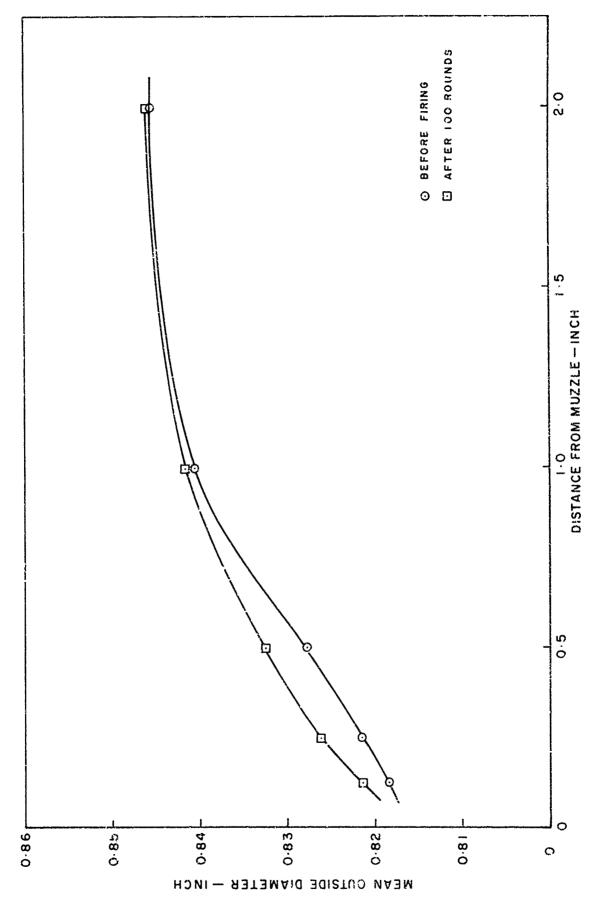
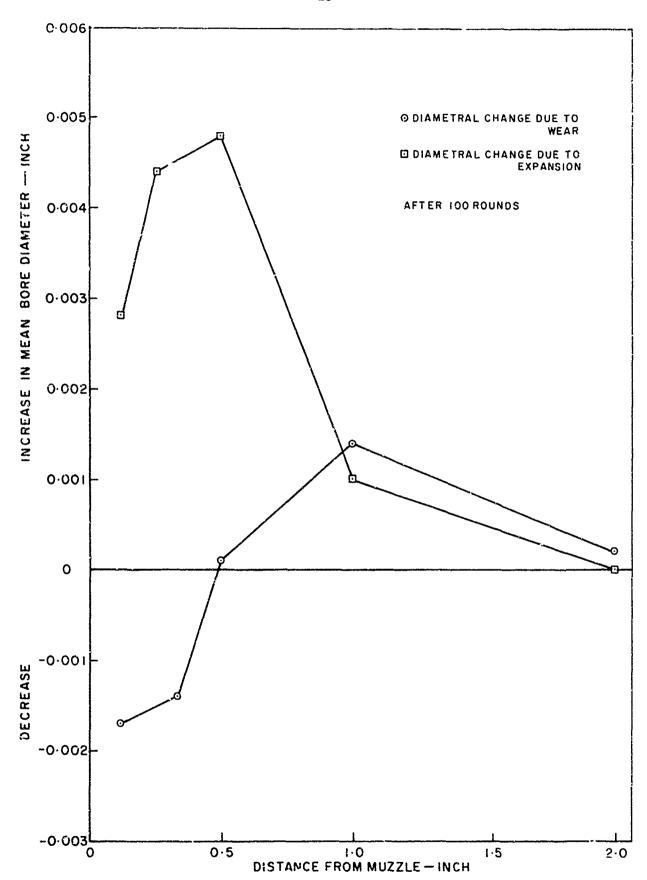
t gnificantly different results were obtained with the other, harder metal pellers the add. Measurements of the barrel from which 100 rounds of uncoated carbonyl ni_ke! sho were fired (_ig. 12 to 14) show that considerable changes in the inside and outside diameters occurred. Wear damage to the inside of the bore was apparent after only a few rounds of shot had been fired. The severity of the damage is apparent from Figures 32 and 33, which are photographs of the bore (at the muzzle), taken initially and after 25 rounds of the nickel shot had been fired. The large increases in the roughness of the bore noted in Table 2 also reflect the severity of the wear process. The degree of surface damage occurring can be better appreciated from the roughness traces of Figure 31. obtained from the plastic replicas made before and after the firing of the test shot. Despite the seriousness of this effect, it can be seen from Figure 14 that greater dimensional changes occurred as a result of the hammering-out action of the train of pellets on the choked muzzle. This is not surprising when it is realized that these nickel pellets were of a hardness in the range 300 - 460 V.D.H. compared with the hardness of the barrel, which was only 210 - 220 V.D.H. The barrel wear, although it is obviously an important effect with these hard pellets, does not cause dimensional changes significantly greater than the measurement errors. However, the presence of negative wear suggested in Figure 14 is supported by visual

evidence of a piling-up action at the muzzle. It seems that the ploughing action of the pellets against the bore could gradually be moving small quantities of the barrel material towards the muzzle, where a burn was formed.
